NON-CONDUCTIVE WASHERS

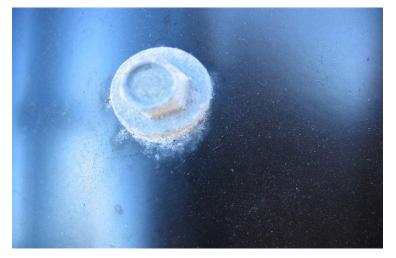
∞ Conductivity

Results after 10 months exposure

Results of corrosion at Bellambi Point NSW, 10 months exposure

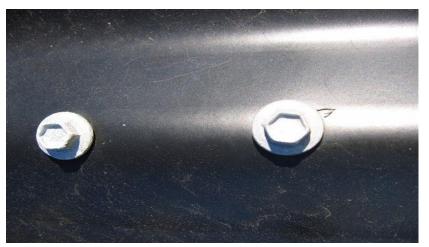
No Conductivity

Results after 10 months exposure

Results of corrosion at Bellambi Point NSW, 10 months exposure
